2013-2020 COLLEGE OF THE ALBEMARLE FACILITIES UTILIZATION AND CAMPUS MASTER PLAN UPDATE

Elizabeth City Campus roof repair, projected cost summary

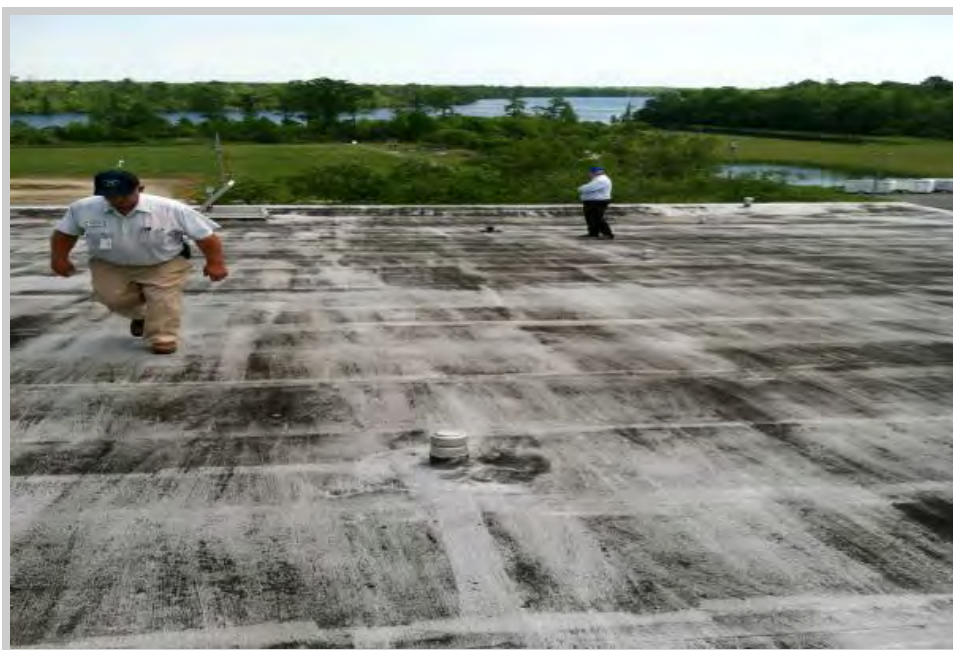
Condition The lower auditorium roof sections benefit from great slope in their deck substrates facilitating fast water run off. Harmful UV rays, thermal cycling and age have lessened the effectiveness of the coating applied to the built-up roof system. Breakdown is most obvious on the perimeter edges at the gravel stop transition between the metal and asphalt membrane. This separation has allowed moisture into the building envelope.

Rooftop view of the built-up roof system. Note the nice slope but the degrading roof coating protection layer.

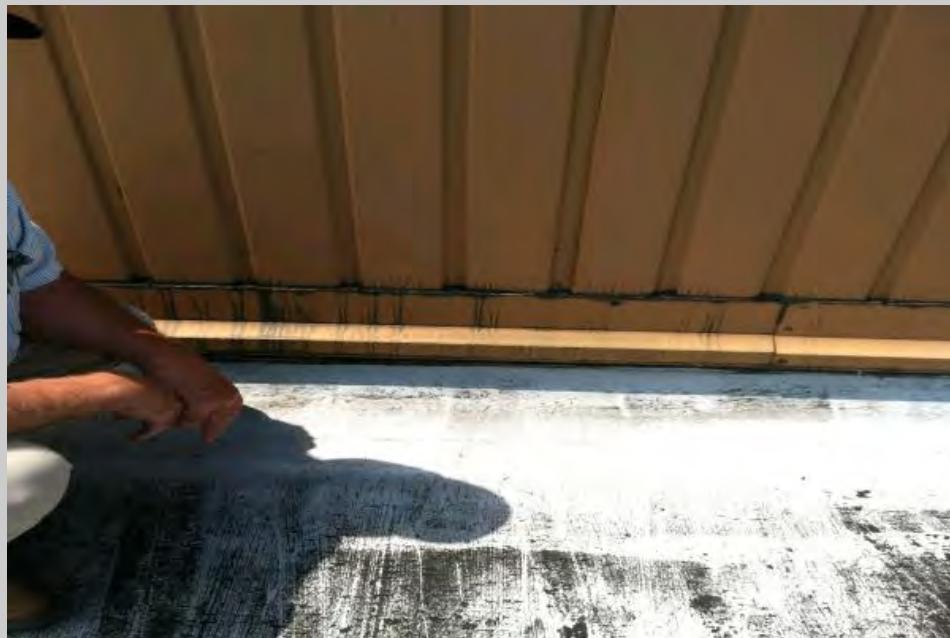
Most of the reported leaks have been evidenced at the roof/wall panel transition as well as the perimeter edge metal detail.

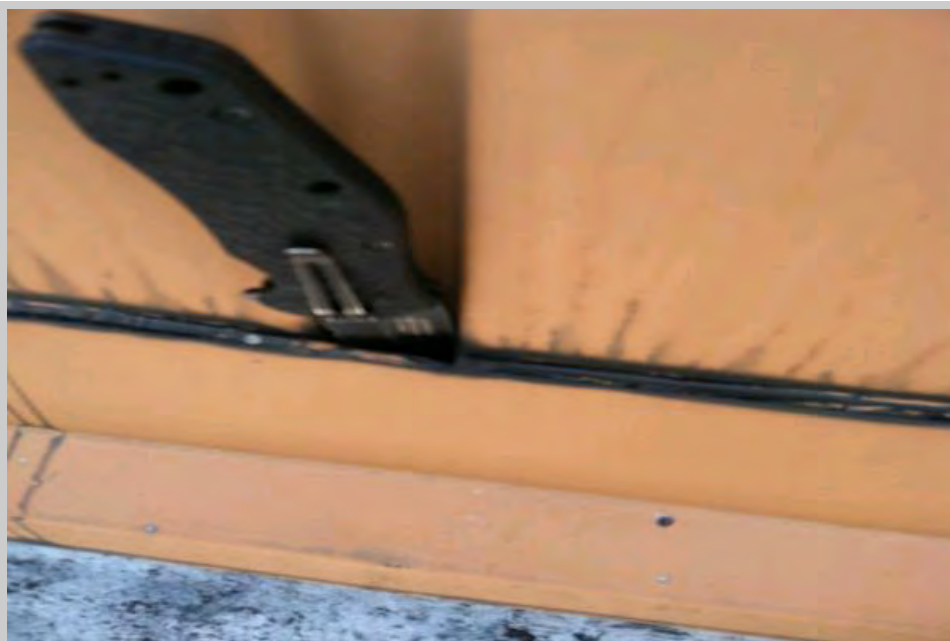
A close-up view of the deteriorated sealant detail at the wall panel roof flashing transition.

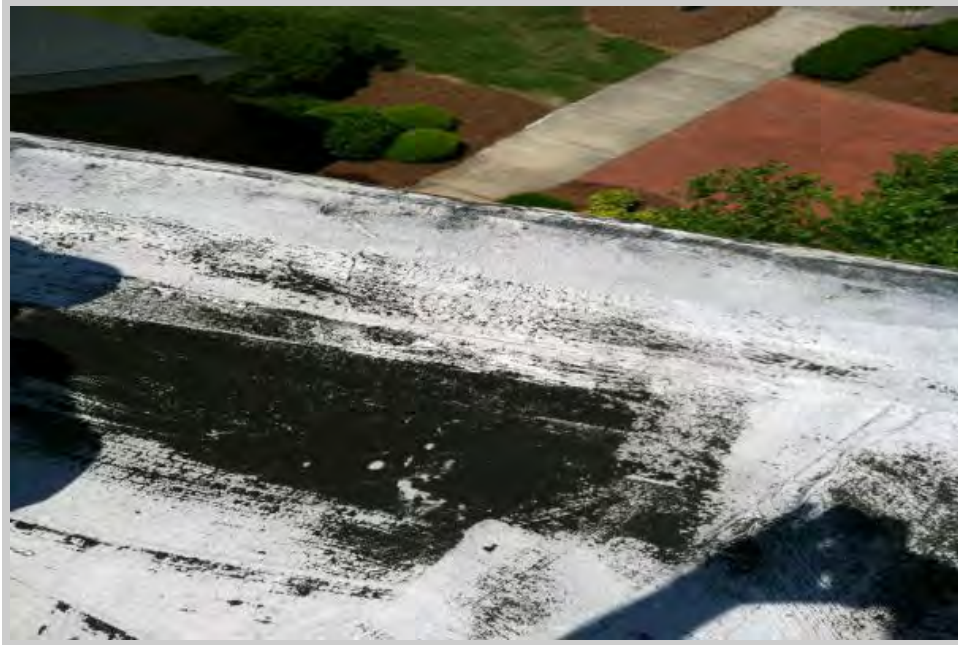
The top membrane ply has separated from the perimeter metal edge.

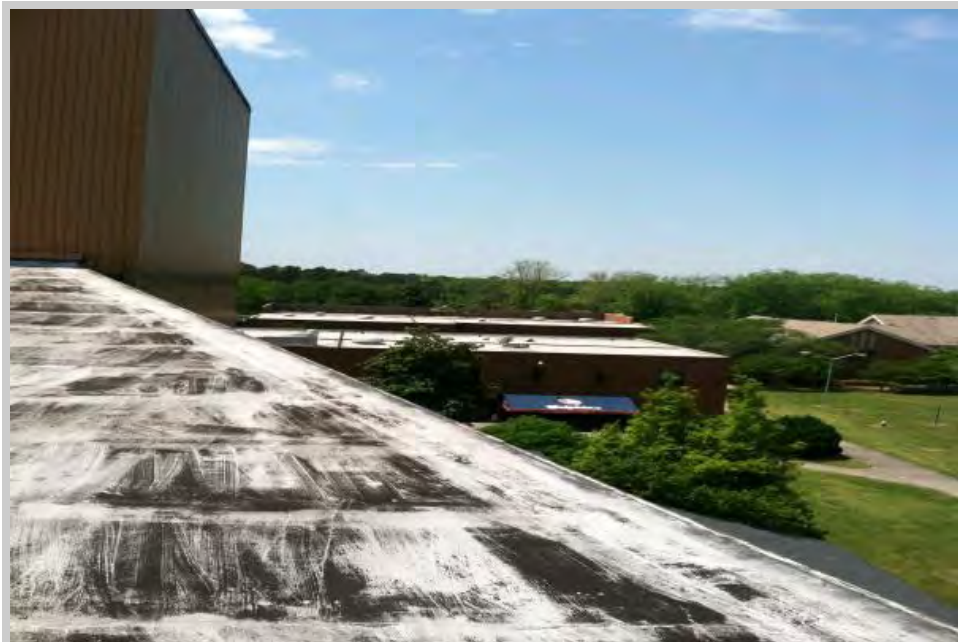
The entire perimeter edge detail needs to be stripped in additional roof plies. Evidence of moisture migration noted at several open points in membrane laps.

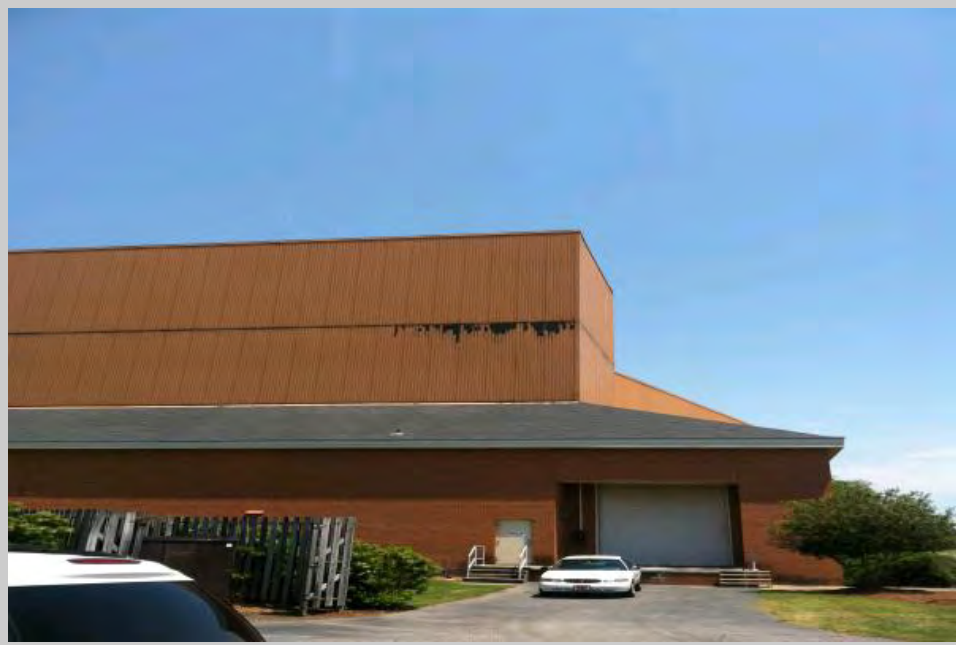
Rust was noted in several spots on the Upper Auditorium wall panel assembly. Identified some evidence of rust repairs in the past. Also, repairs have been made to the base wall panel low roof transition detail in areas to slow the flow of moisture migration into the building envelope.

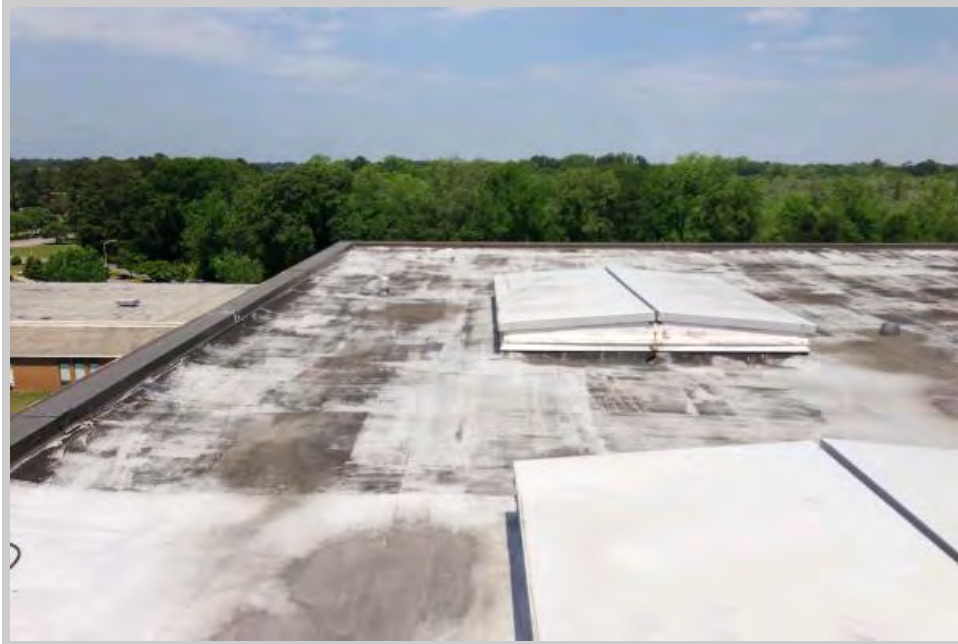
Rating	Poor
Condition	Water is under the roof system and has entered the building envelope. The R value of the wet insulation has diminished. The perimeter metal edge detail has failed allowing water into the roofing system.

Rooftop overview picture of the Upper Auditorium roof section.

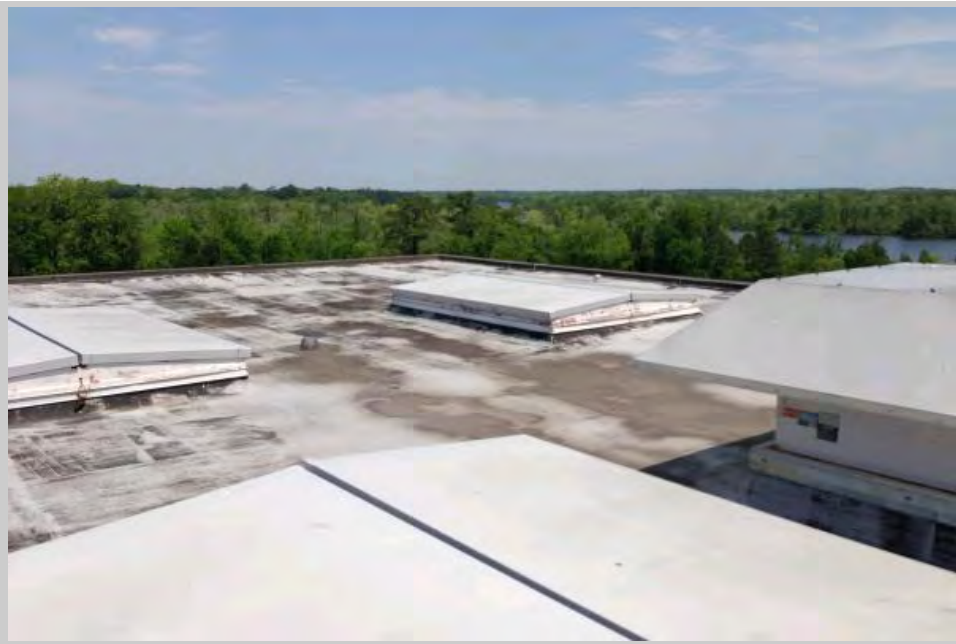
Another rooftop overview. Note the rooftop projections.

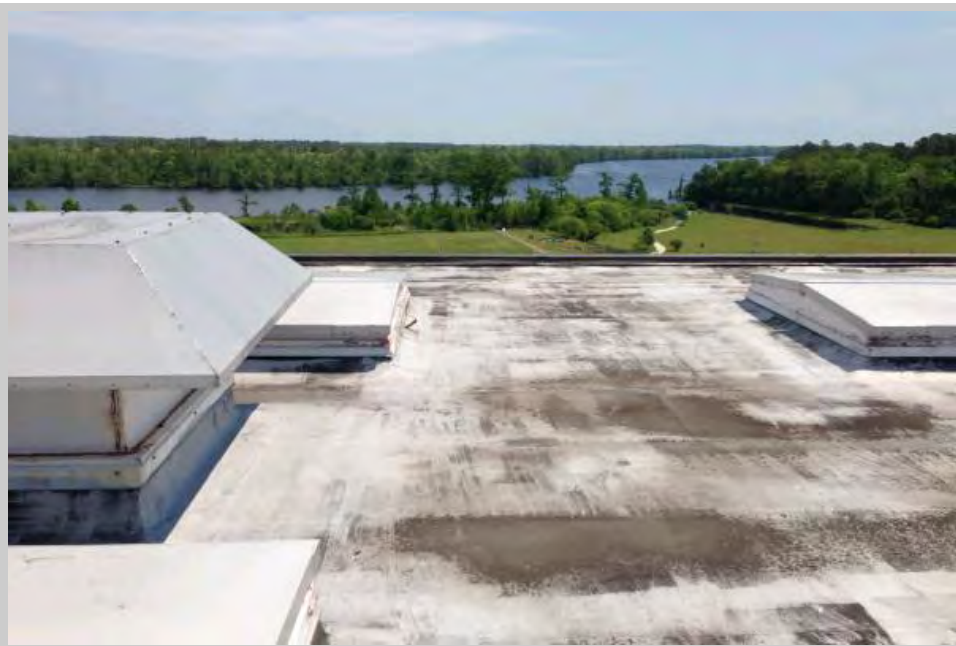
The perimeter edge metal has failed allowing moisture to migrate to the field of the roof.

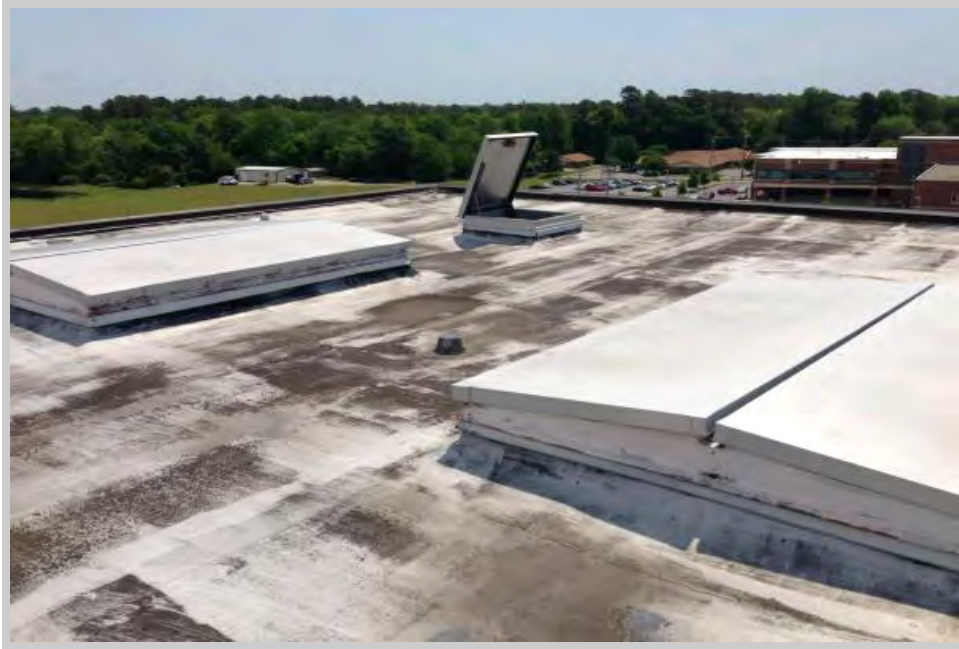
The rooftop penetration flashings are in fair shape. The trapped moisture is running from the building perimeter.

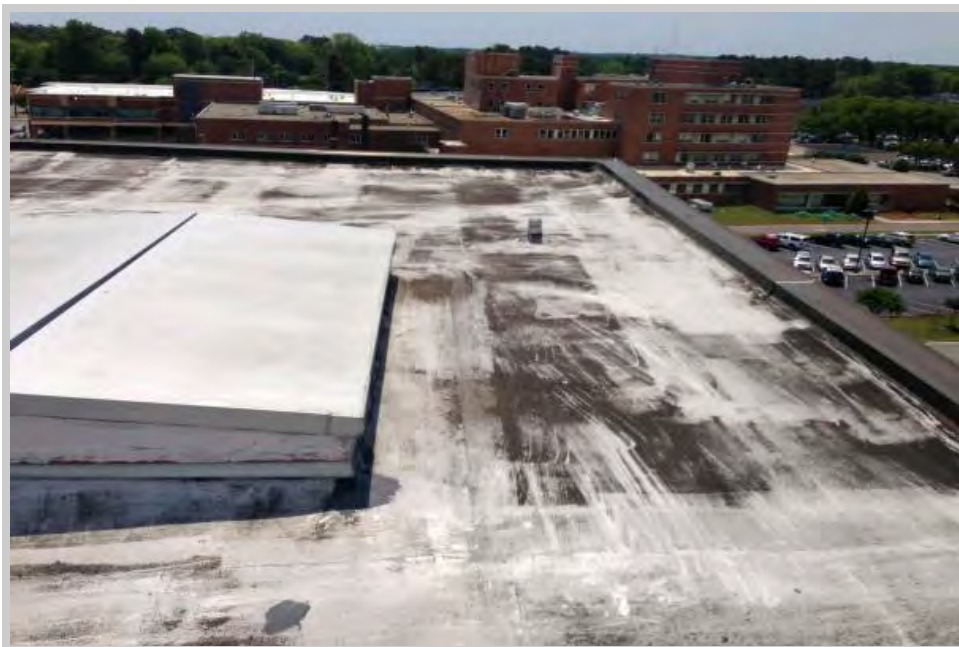
A rooftop view of the failed perimeter edge metal detail.

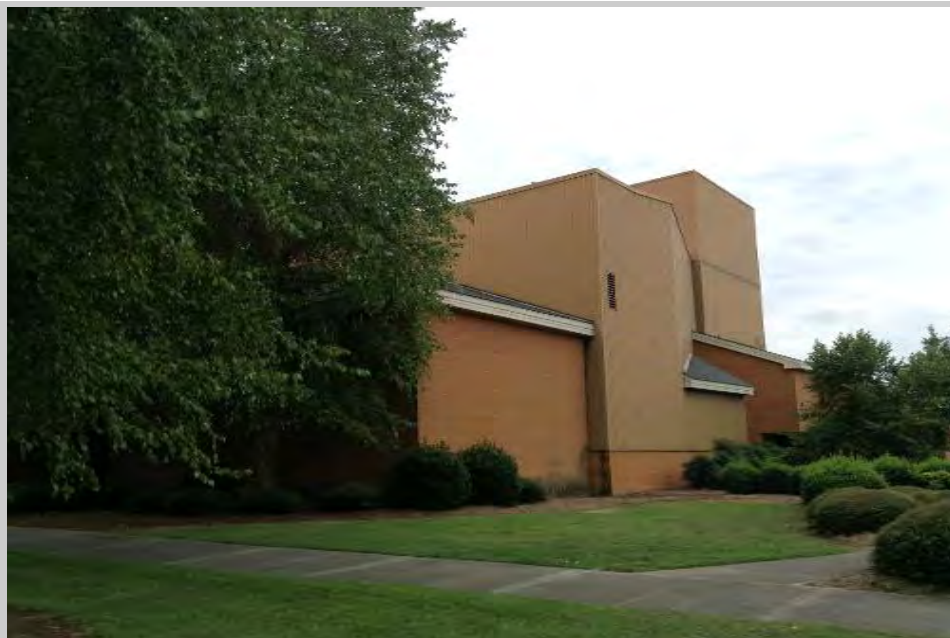
Rating	Fair
Condition	Currently the upper auditorium wall panels are an eyesore on a beautiful college campus. Some reactive and proactive flashing repairs have slowed any moisture intrusion into the building envelope. A long term solution needs to be examined and budgeted. Indoor air quality issues and or a rusted metal support substrate are much bigger budgetary concerns.

Side view of the upper auditorium wall panels.

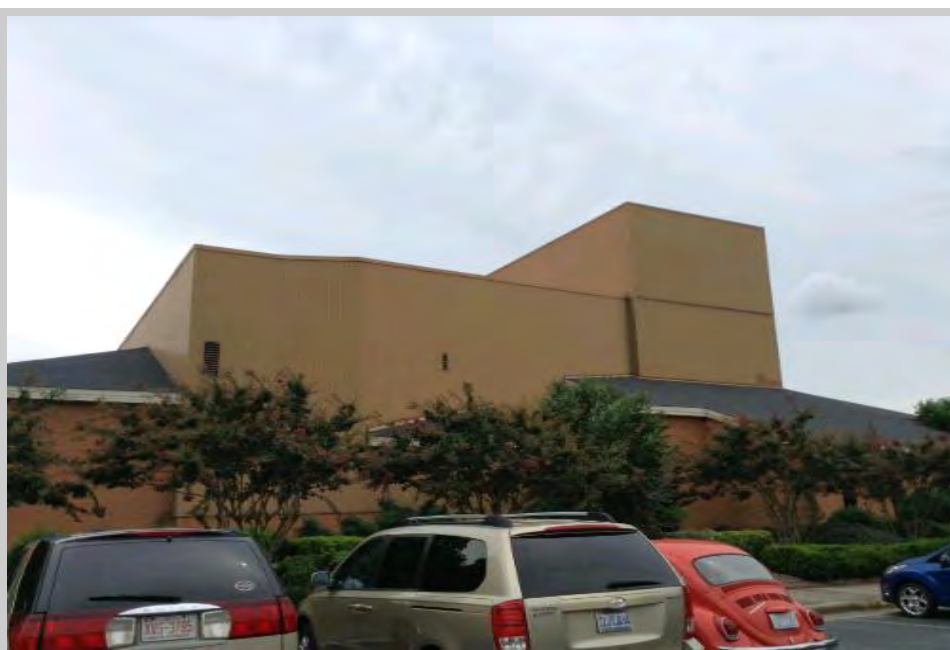
Other Side view of the upper auditorium wall panels.

Action Year:	2014
Section Square Footage:	11,000	Expected Life Years:	30
Estimated Cost:	\$200,000.00		
Scope of Work:	Install new metal hat channels anchored into the existing metal framing. Install 16" .040 aluminum panels per manufacturer guidelines. Install all clips, closures and trim pieces per manufacturer's recommendations to receive metal panels. Install all flashings, counterflashings, closures and sealants as required by manufacturer. Manufacturer technical inspections required during installation for quality assurance.

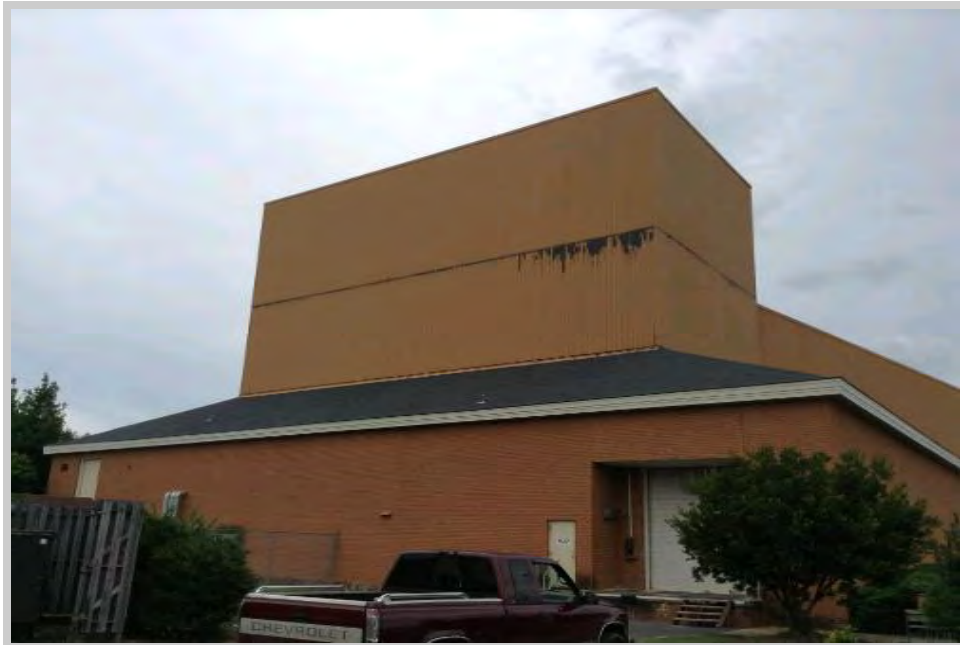
Front view showing oxidation and chipping paint on the upper auditorium wall panel system

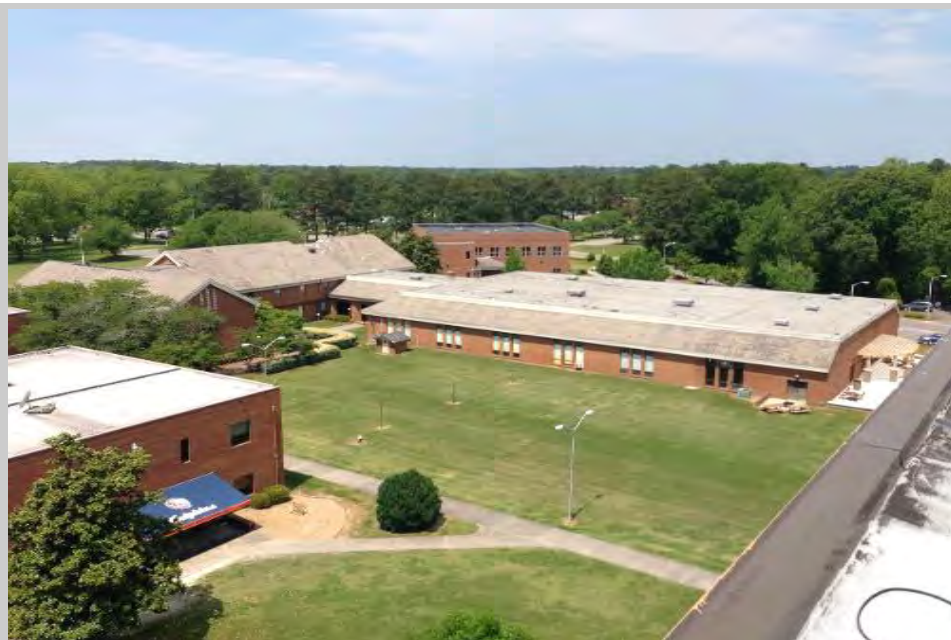
Rating	Fair
Condition	The sprayed polyurethane foam (PUF) roof is in fair condition for it's 10 plus years of age. There are some minor areas that need corrective action and a few low areas of ponding water.

Overview of the foam section roof

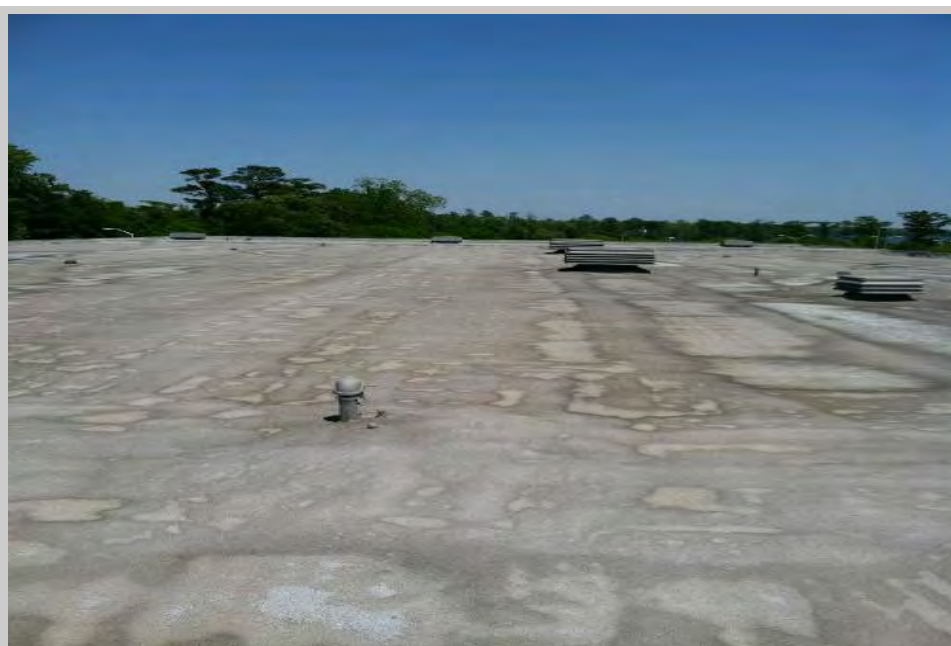
Overview of the field of the roof.

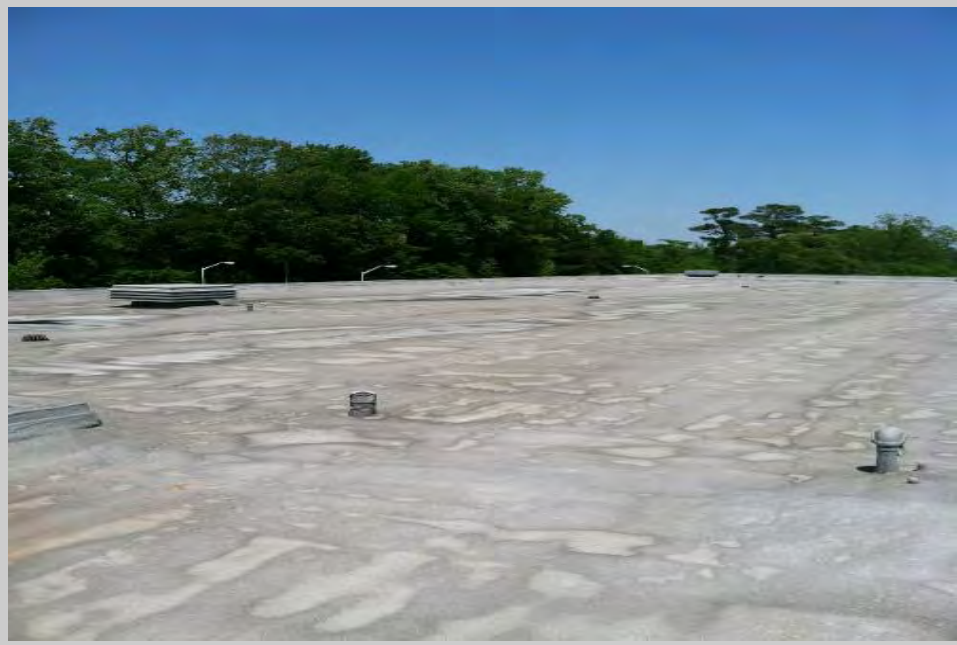
Roof Overview of the sprayed foam polyurethane roof system coating.

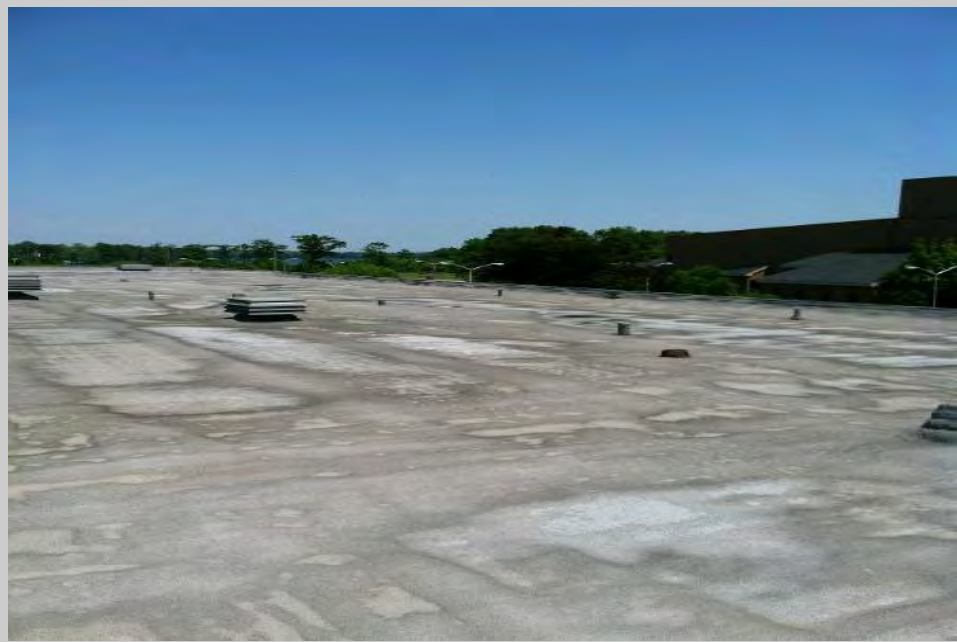
Rooftop view of the many penetrations located on this roof section.

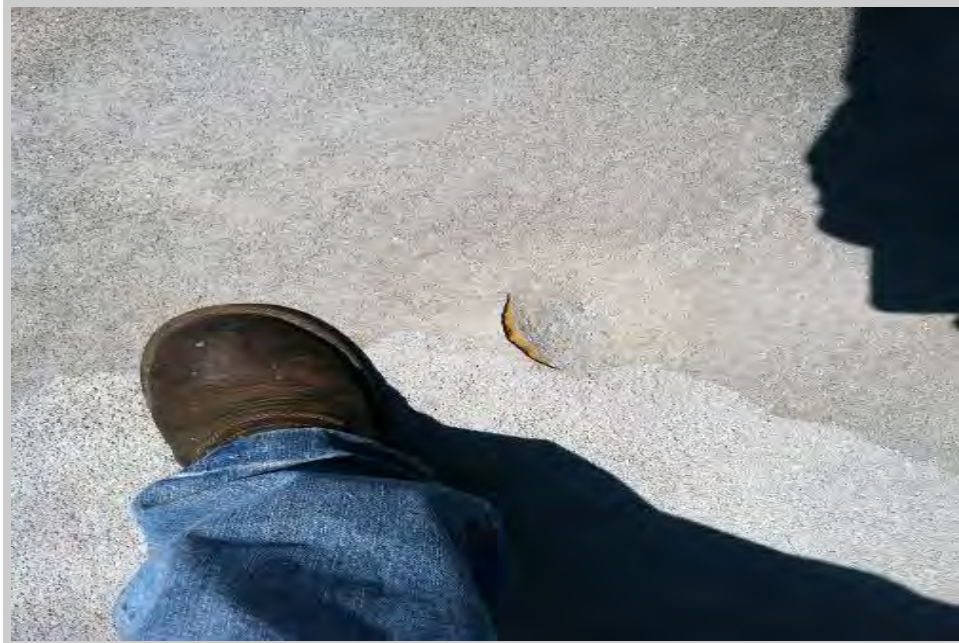
Asplit in the sprayed polyurethane roof section.

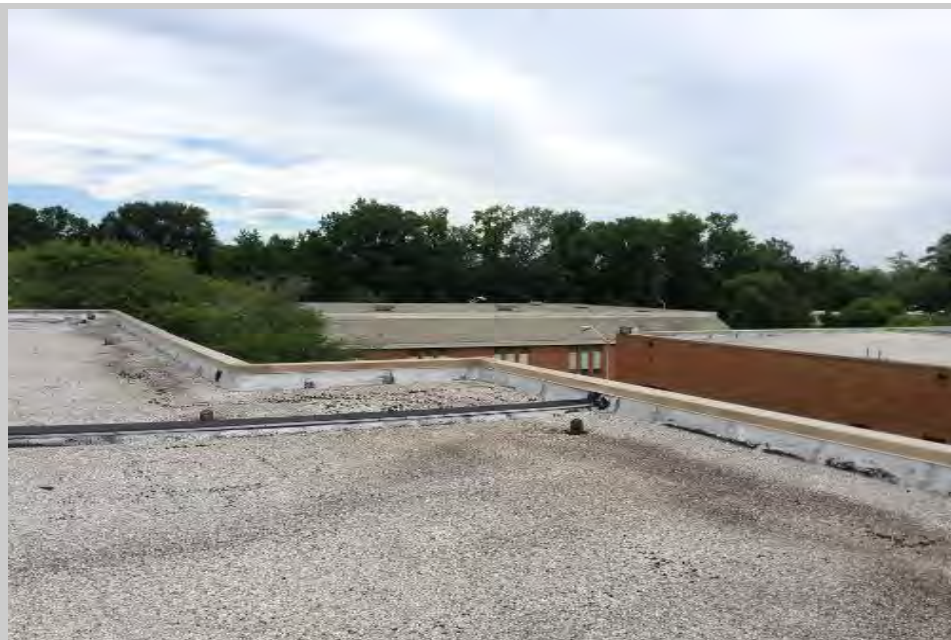
Building C mansard shingle rooftop overview.

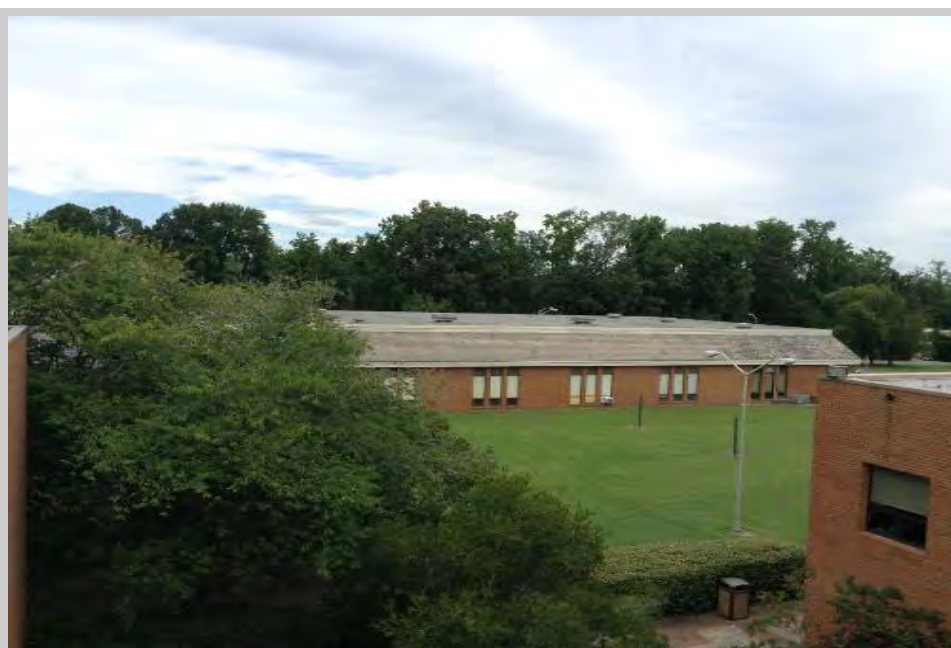
Overview, of one side of the building C mansard. There are 3 other sides to the building C mansard roof areas.

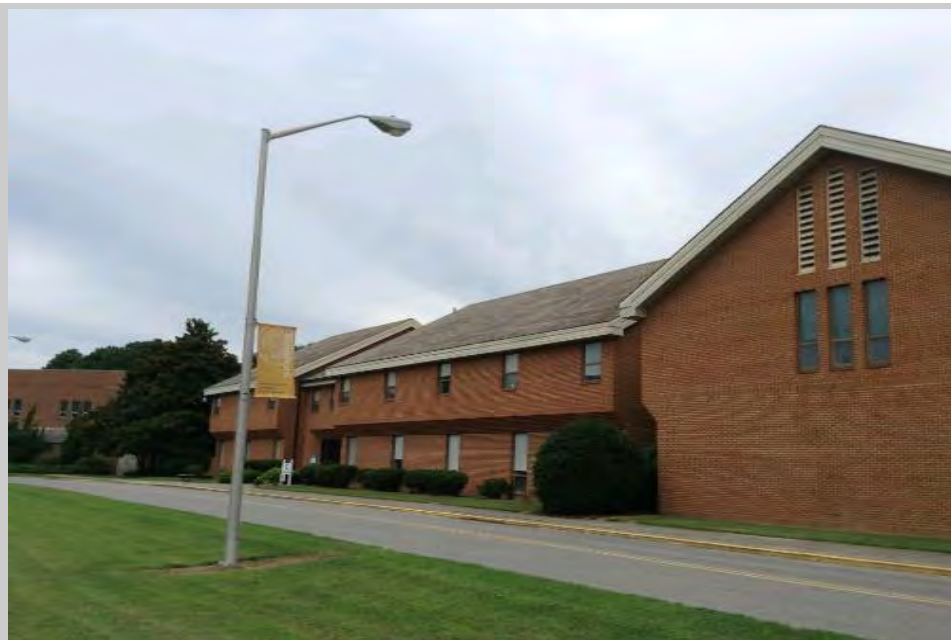
Rating	Fair
Condition	The large area of asbestos shingles between the Library and Building C are fastened with 1 or 2 nails into the structural concrete deck. High uplift pressures exert a strain on this installation method. Reactive and proactive repairs have been attempted. The loose shingles present a safety concern for maintenance personnel and anyone walking under foot the perimeter.

Overview of Building C and the asbestos shingles on the front portion side. There are many missing shingles near the ridges and on the back seaward side of Building C.

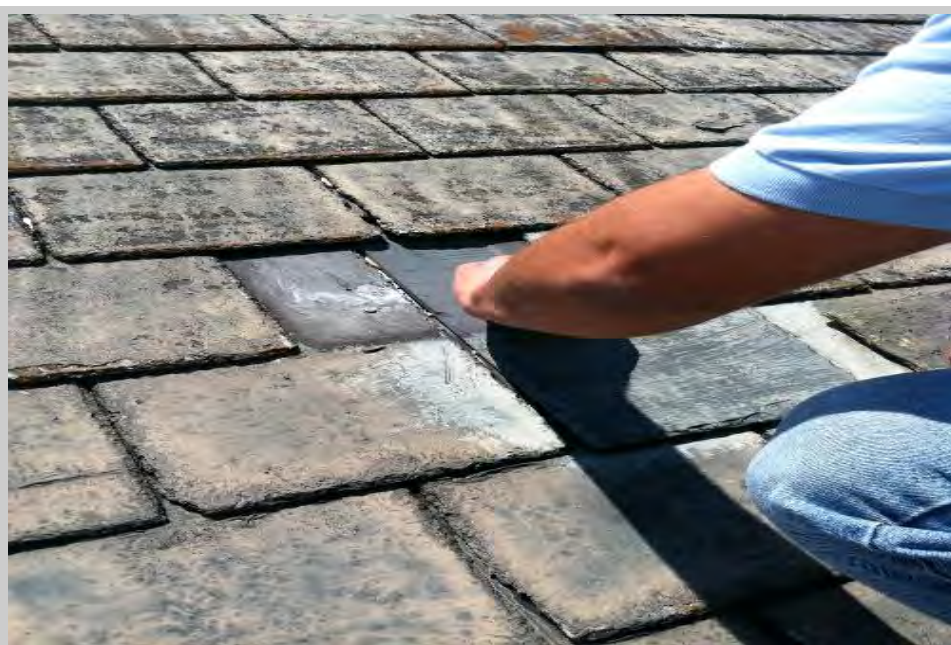
Rooftop view of the condition of the asbestos shingles on the building C. The College of the Albemarle Maintenance department has been very proactive and reactive in replacing worn or blown off shingles over the years.

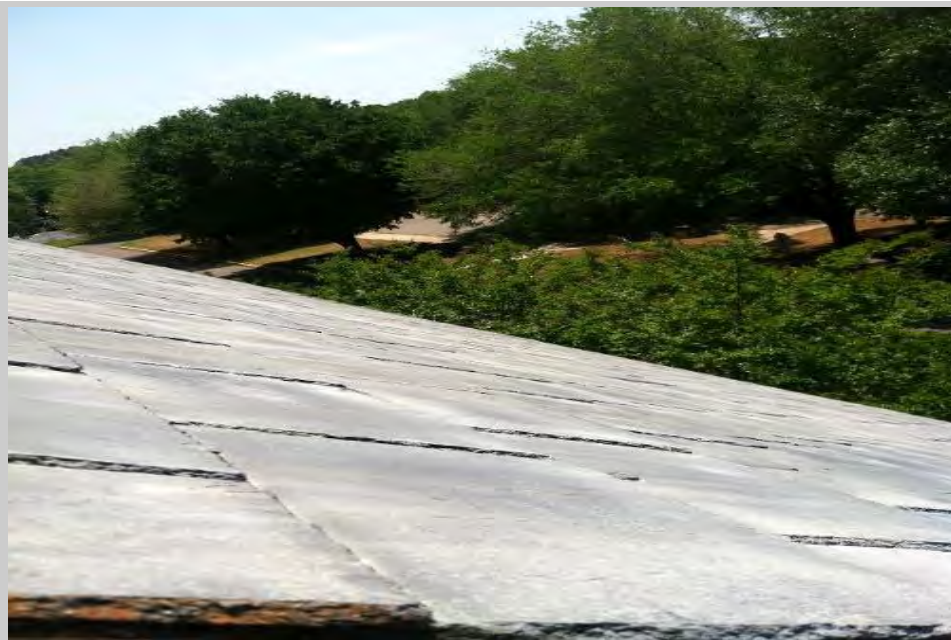
Rating	Fair
Condition	The asbestos shingles on the Library mansard are located in a high wind pressure location. These high uplift pressures exert tremendous strain on the 1 or 2 nails per a shingle attaching them to the structural concrete deck. Testing confirmed the presence of asbestos in the shingle composition.. Maintenance personnel have repaired/replaced shingles over the years. There are many loose shingles raising a safety concern for the current reactive repair/replacement process. Also, the steep slope and area under foot could see falling shingles after a high wind event.

Rooftop view of the Library mansard asbestos shingles. Note the great slope that has prolonged the life of the shingle. Many shingles are loose or have been repaired/replaced.

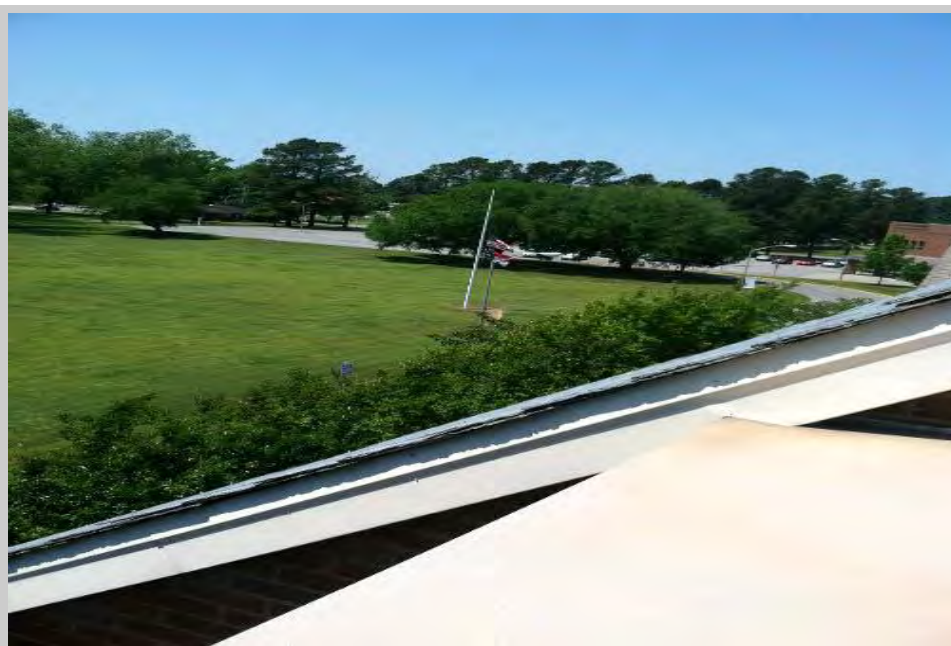
Rooftop view of the mansard roof section of the Library. Many of the shingles have been repaired or replaced.

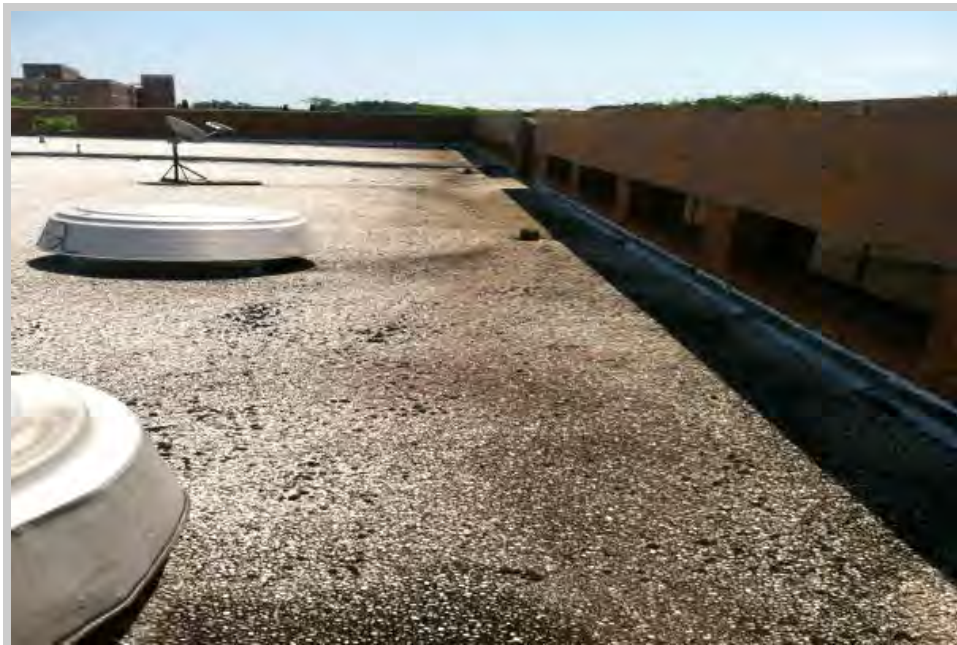
Rating	Fair
Condition	The built-up roof with flood and aggregate surfacing on the Library roof system is a fine system that needs some reactive and proactive repairs to extend the lifecycle of the roof asset. These repairs should eliminate the current leaks and extend the life of the entire roof system.

Wall flashing that needs to be stripped in with a new base and cap sheet.

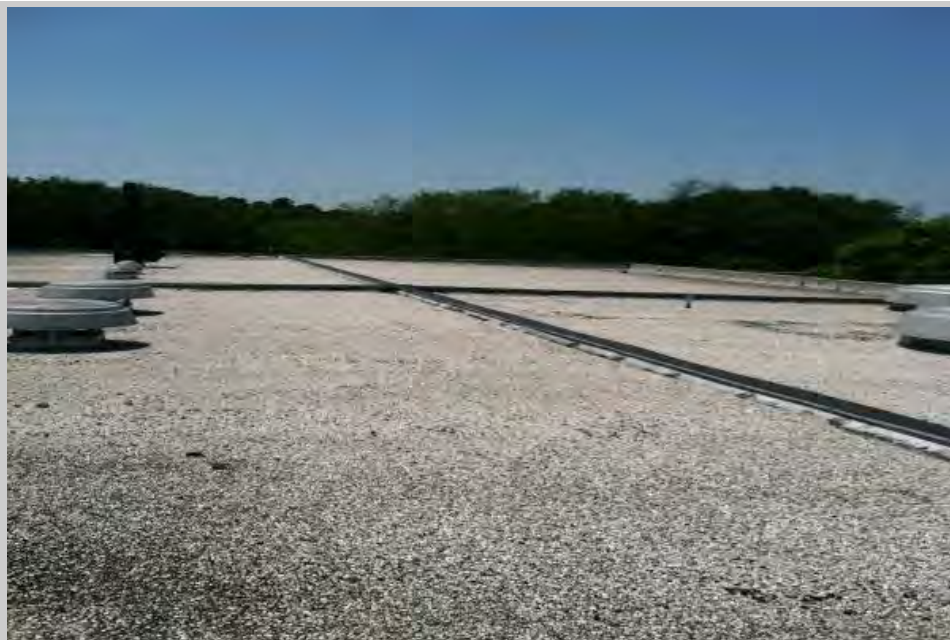
Rooftop view of aged expand o flash neoprene expansion joint. Some preventative maintenance has been performed on these suspect roof transition points.

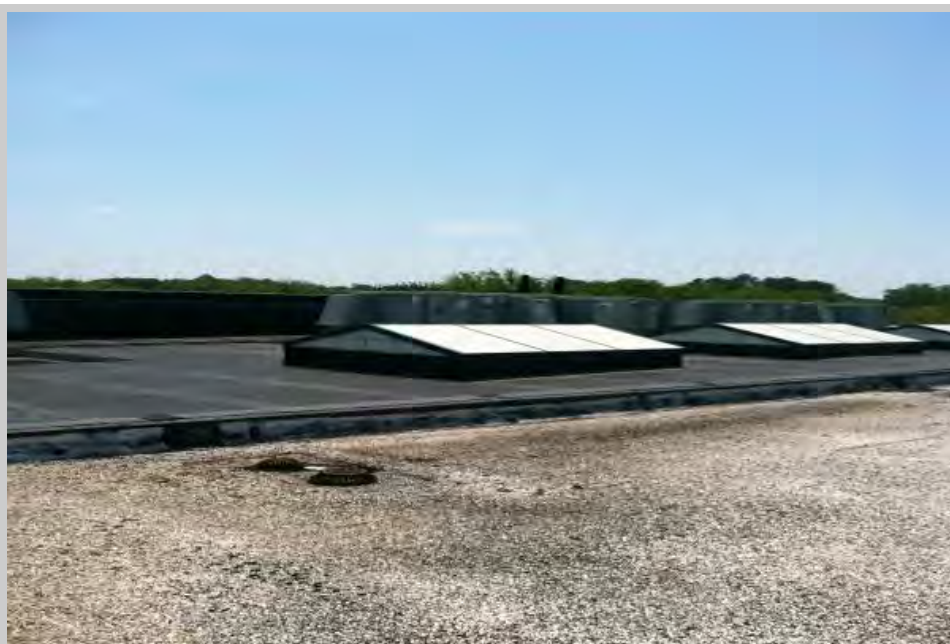
Rooftop view of aged low base flashing.

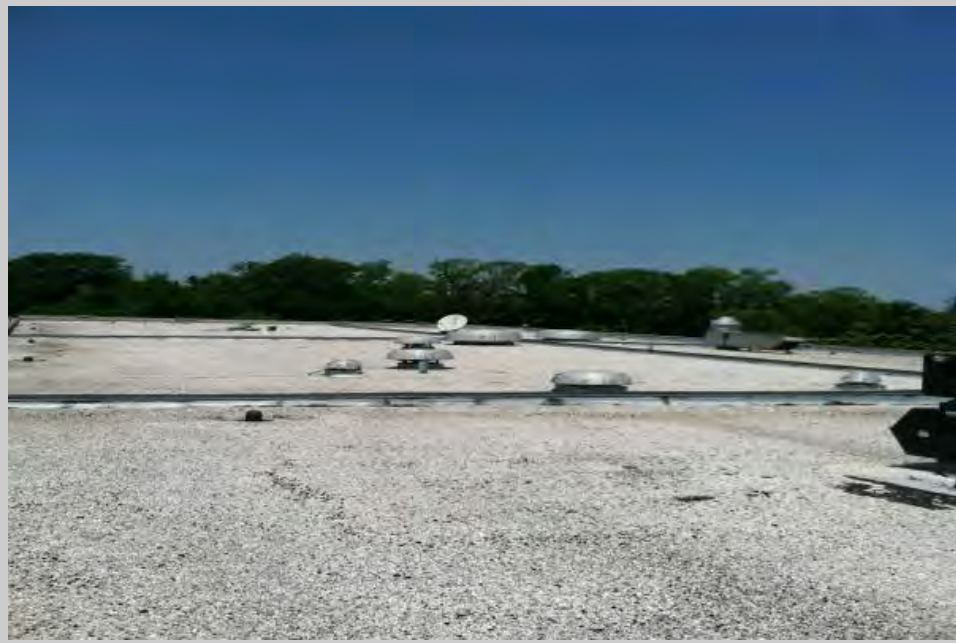
Another rooftop view of aged flashing details.

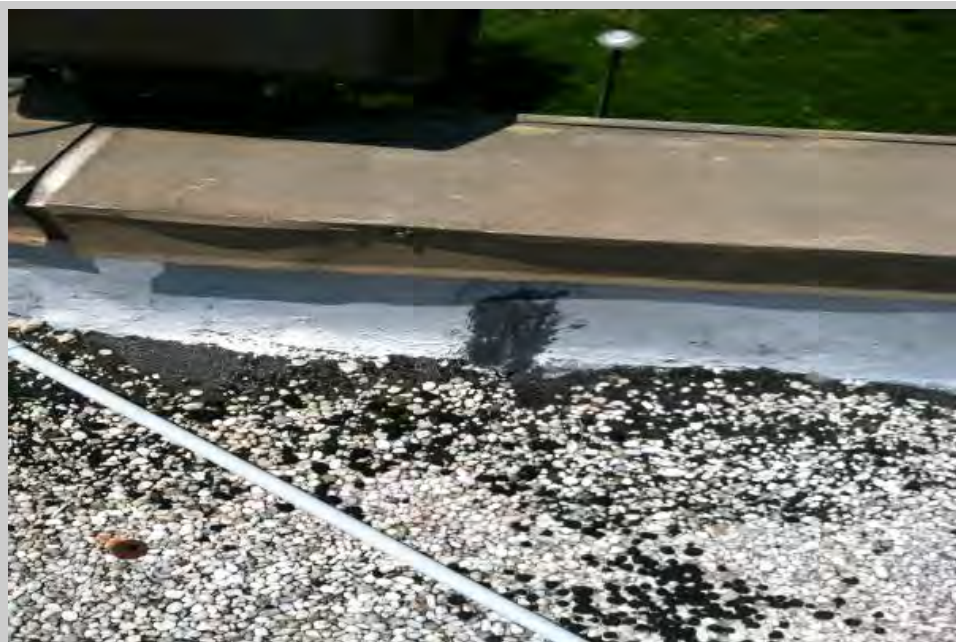
A rooftop view of a loose metal coping cap and repaired base flashing detail.

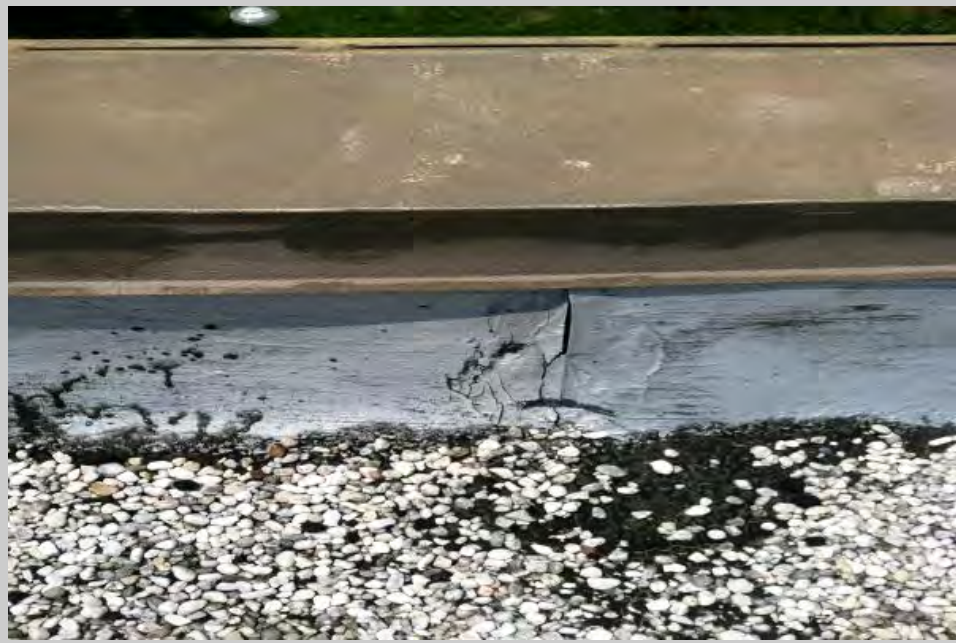
Rooftop view of open lap joint on the base flashing.

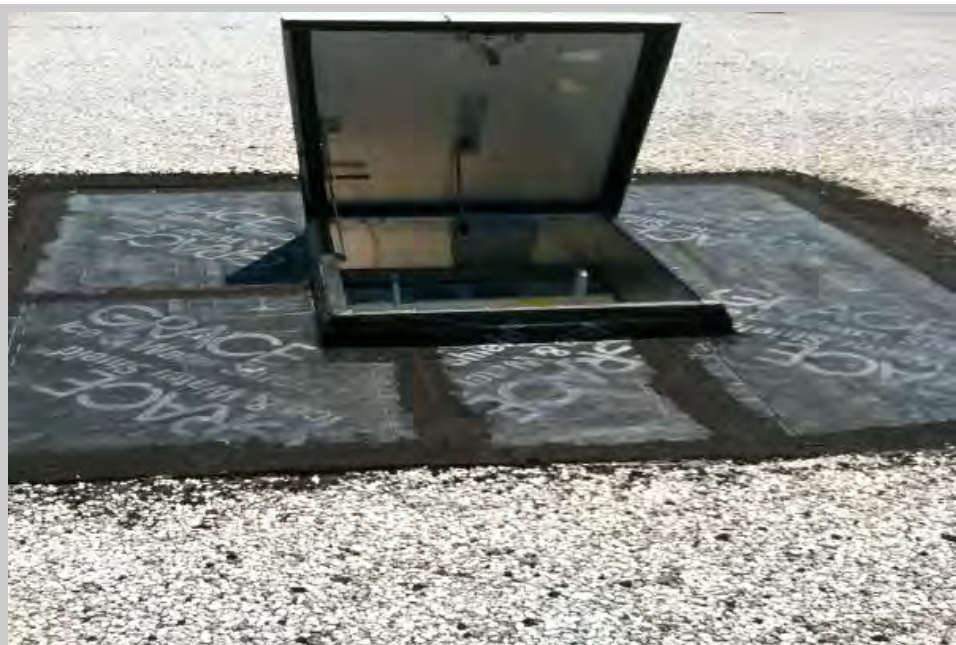
The College of the Albermarle maintenance dept has installed a temporary solution peal and stick membrane slowing the water flow into the building envelope around this roof hatch.

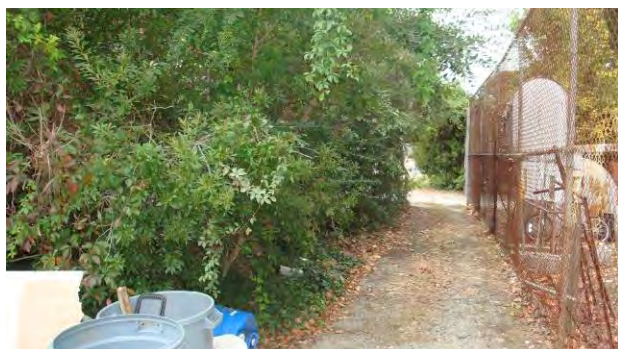
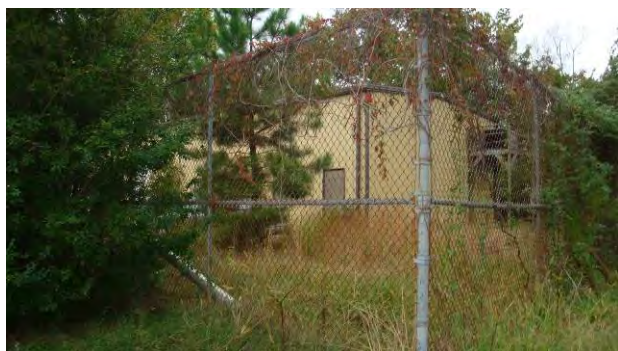
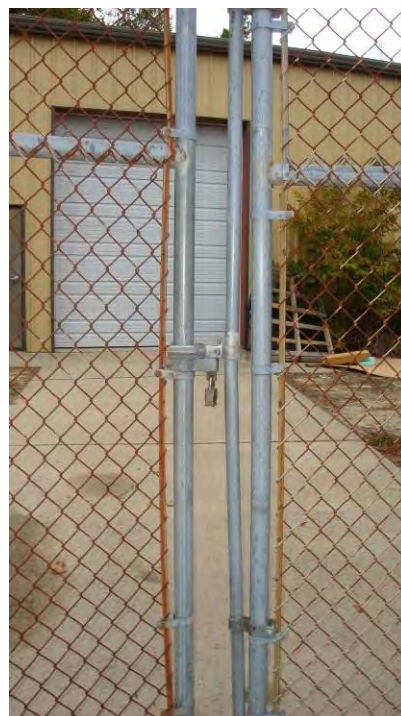
Based on the assessment conducted, fencing although preferred does not appear to be feasible or practical at this time. Fencing is being utilized to protect areas where large assets are stored in an effective manner. Some of the fencing was in less than ideal condition with vegetation growing on it, which gives persons with nefarious intentions both additional assistance in breaching the fence line and anonymity as it blocks the casual surveillance of passersby.
