2013-2020 COLLEGE OF THE ALBEMARLE FACILITIES UTILIZATION AND CAMPUS MASTER PLAN UPDATE

Elizabeth City Campus roof repair, projected cost summary

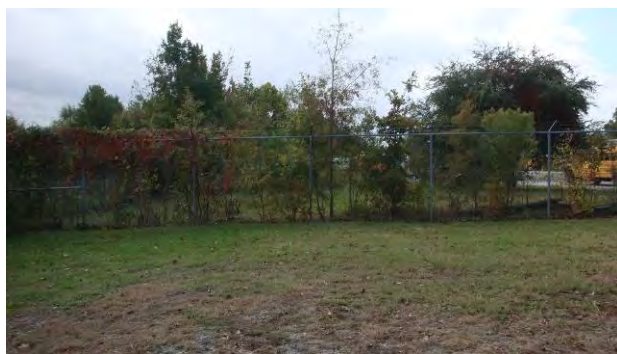
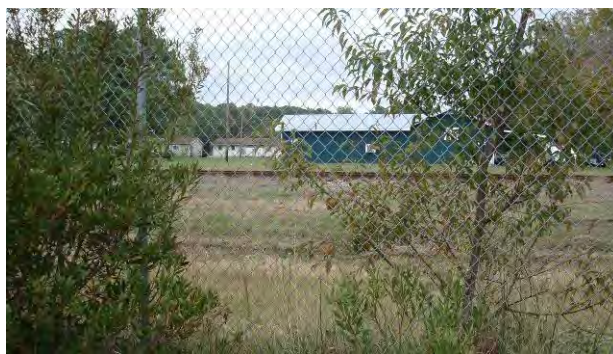
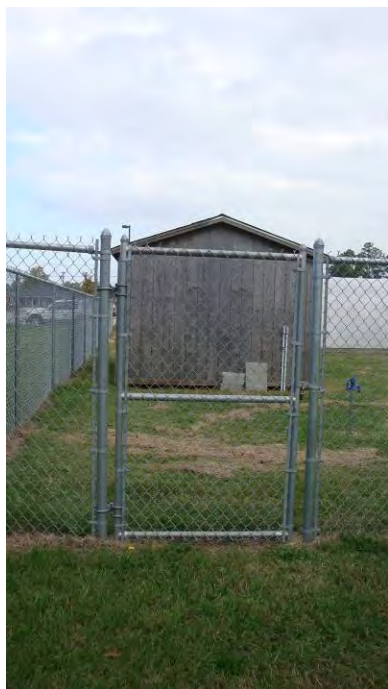
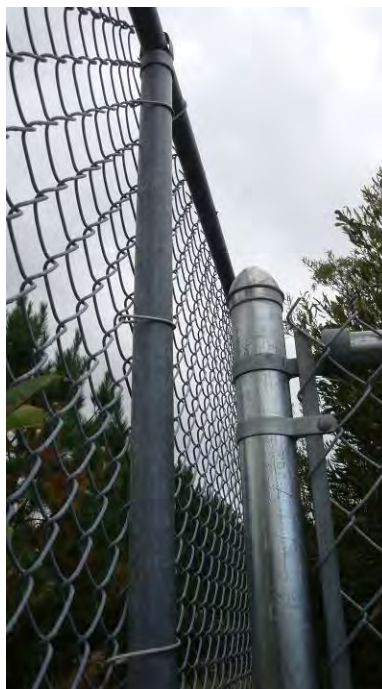
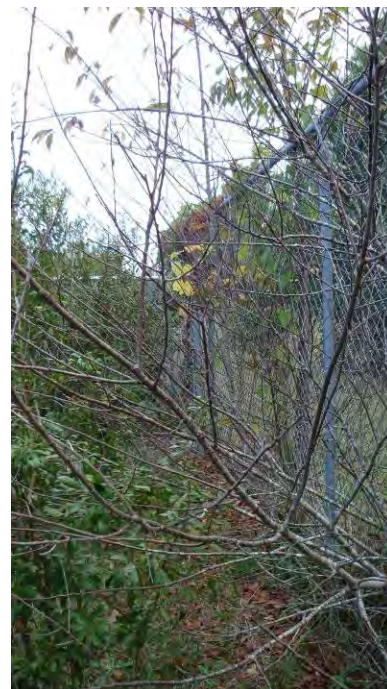
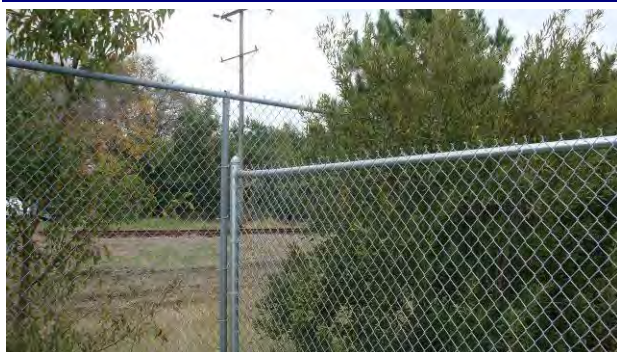
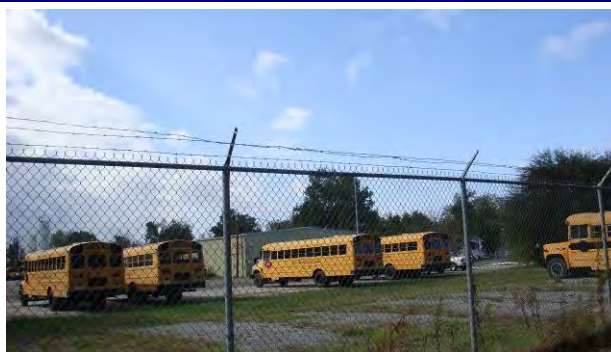
Based on the assessment conducted, fencing although preferred does not appear to be feasible or practical at this time. Fencing is being utilized to protect areas where large assets are stored in an effective manner. Some of the fencing was in less than ideal condition with vegetation growing on it, which gives persons with nefarious intentions both additional assistance in breaching the fence line and anonymity as it blocks the casual surveillance of passersby.

Vulnerability: Based on the accessibility and the multiple constituents that may be visiting the campus property at any time, the campus may be seen as an easy target.

Risk: An unauthorized person could enter undetected and cause injury or asset loss.

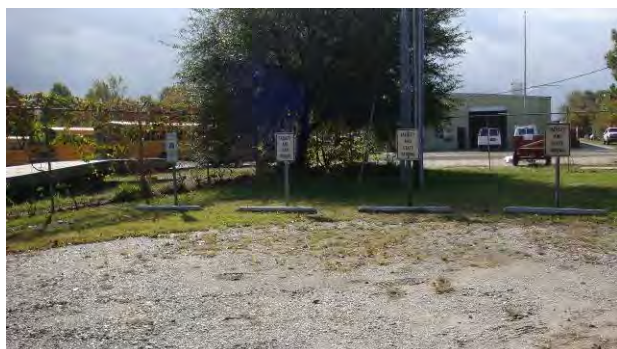
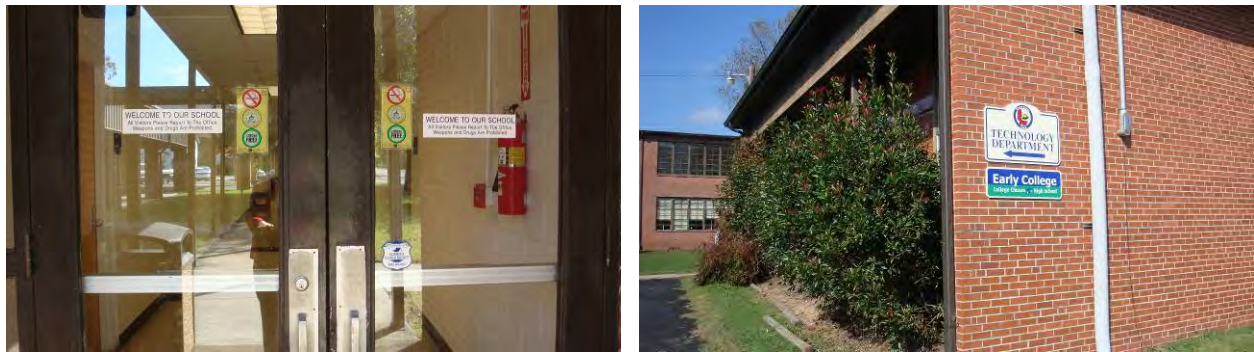
Eastern North Carolina as a whole is located in an area that is subject to weather events (such as high winds, tornados, hurricanes and occasional snow storms etc.) in addition to other emergency and critical events. The campus has students, non-students, faculty, and staff that access its property and facilities. With a growing enrollment and need for the educational and other opportunities and services that the college provides, signage is imperative to facilitate the wanted behaviors and protect the assets of the COA. In addition, it allows the college recourse upon infractions. During the consultant's visit, there were numerous examples of the college effectively using signage to address safety issues and the "No Smoking" policy.

Vulnerability: No clear message about desired behaviors is provided to individuals coming on to campus.

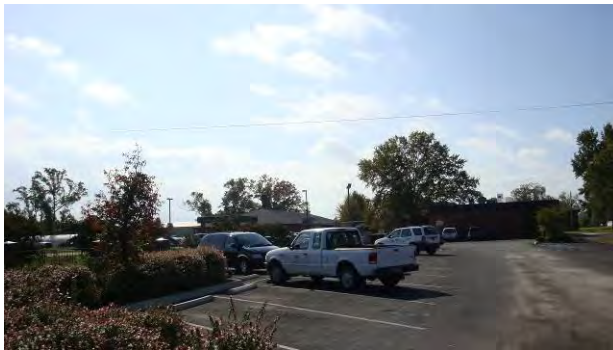
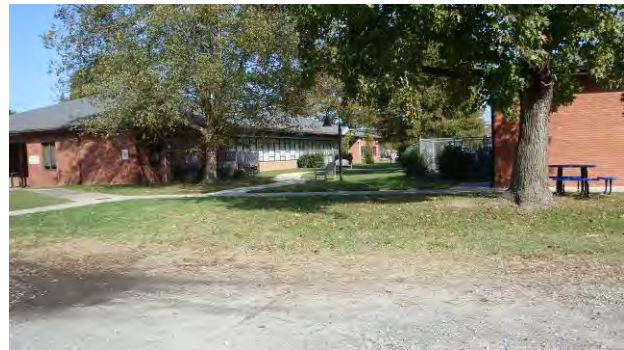
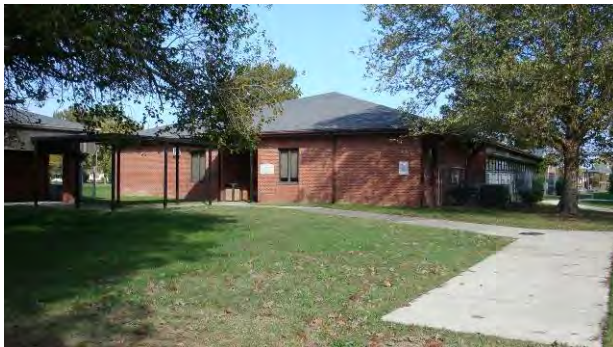
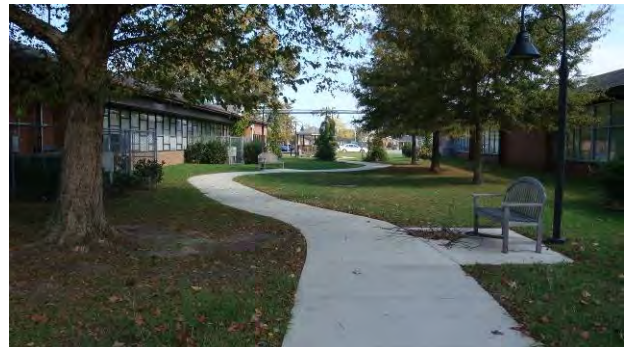
The COA Edenton-Chowan Campus at North Oakum Street is attractive with a large variety of shrubs and mature trees that can be seen throughout the property. Security and beauty are not mutually exclusive. The balance is in how the trees and other foliage are maintained. Without careful maintenance, trees will block casual surveillance and provide hiding places for people with nefarious intent to both persons and property. In addition trees and shrubs are blocking the lighting which darkens areas and could lead to accidents and nefarious behaviors.

Vulnerability: Trees with limbs below the 7-foot level and shrubs with foliage above the 2-foot level make the possibility of concealment easier and can prevent both casual surveillance and surveillance by patrolling guards.

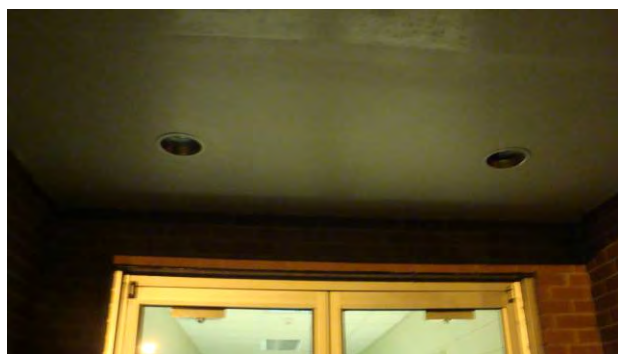
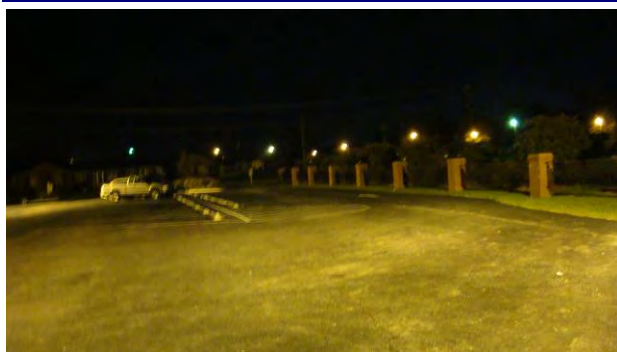
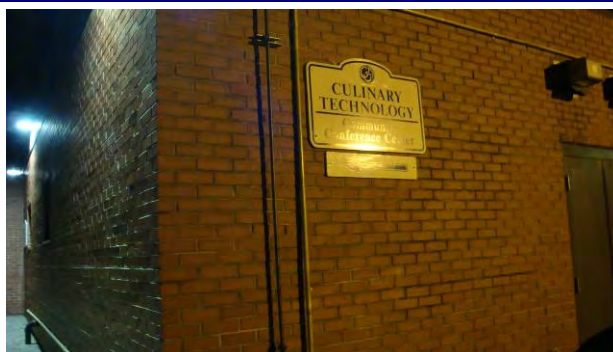
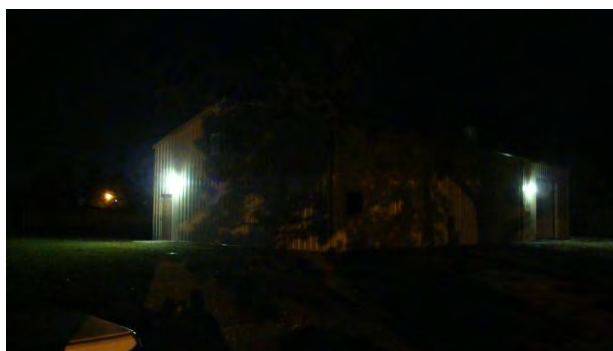
The Edenton-Chowan Campus lighting was pretty good with respect to the parking areas on the south side of the campus, and sidewalks were measured at or above accepted general industry standards when the lights were close enough together, not burned out or blocked by vegetation. Large trees and vegetation were blocking the effectiveness of the lights in specific areas and created dark areas that were below the general industry standards. Along the sidewalks that connected the campus buildings, there had recently been some lighting added that enhanced the security posture of the campus in addition to the safety. Lighting at building entrances were generally below the minimum standards at both campuses. In addition, the lights at the entrance to the ESC office were out which did not help the lighting at the entrance of the Edenton-Chowan Administration Building. All the lights should be evaluated and if possible maintained to the greatest lighting output possible. Lighting levels should be reviewed again after any maintenance on existing lights is complete and vegetation that is minimizing the effectiveness of light output is removed or brought up to CPTED minimum standards.

The parking lots at the front of the campus were reviewed based on the minimum standards for lighting in parking lots. In areas of the lot where the existing lights were not obstructed by vegetation and the existing light fixtures were working, the lighting met the minimum standards. In areas of the parking lots where the parking spaces were shaded by trees or lights were not working, the lighting dropped below the minimum standards.

Vulnerability: Low light conditions exist in the areas listed above.

Recommendations: Repair cycling light fixtures and replace burned out bulbs in fixtures. Add or install adequate lighting in areas that do not meet the minimum standards. Develop a procedure and timetable for the regular inspection and repair of campus lighting fixtures.

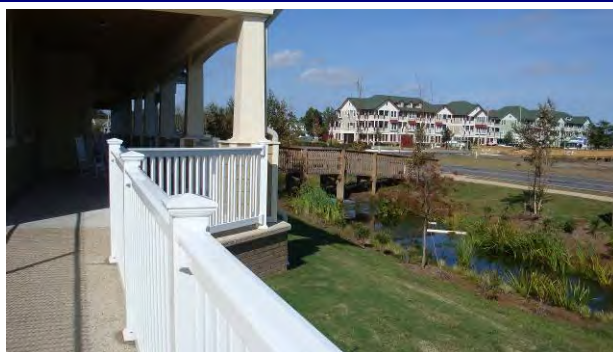
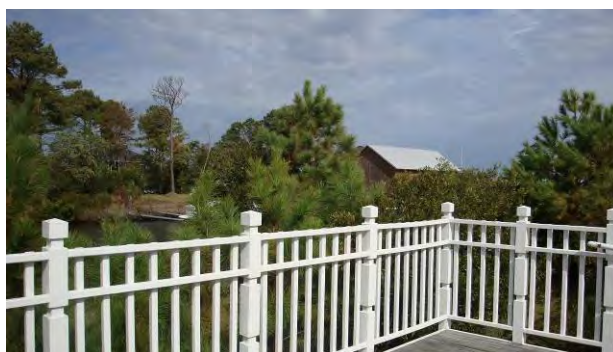
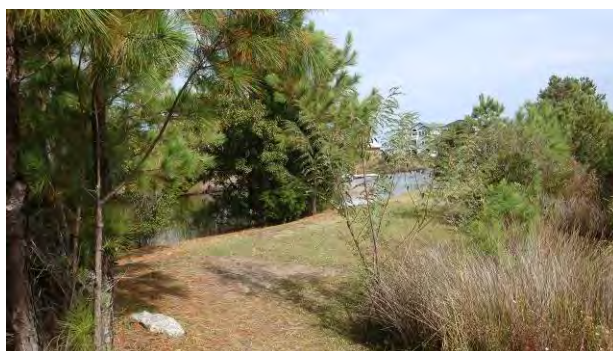
The Russell Twiford Campus has a combination of natural and structural barriers that identify the perimeter of the campus. The north end of the campus is buffered by an inlet that comes off of the Roanoke Sound. Trees and vegetation form a barrier beginning at the north side of the parking area to the west of the campus around the back along the water to the east side of the campus where it ends at the entrance to the east parking area. In addition on the east side of the campus a decorative fence line follows the tree line. Along Twiford Road there is a combination of natural barriers and a short fence that is most likely intended to keep people from parking there but also identifies the property line at the street. Unique at the Russell Twiford campus is the porches and wooden walkways that link the buildings. All of the walkways have rails that serve to control how people access the buildings and where they go on campus. These layers of barriers are subtle but effective at the Russell Twiford campus. As at other campuses, the Russell Twiford and Roanoke Island Campus facilities are accessed by a combination of people who work and/or study at the COA as well as people who are there to utilize campus and county assets such as the Diane Baum St. Clair Technology Education Center or the views of the natural areas from the deck areas and chairs provided on those spaces.

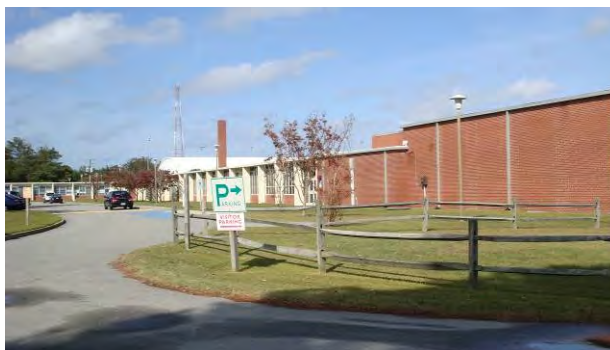
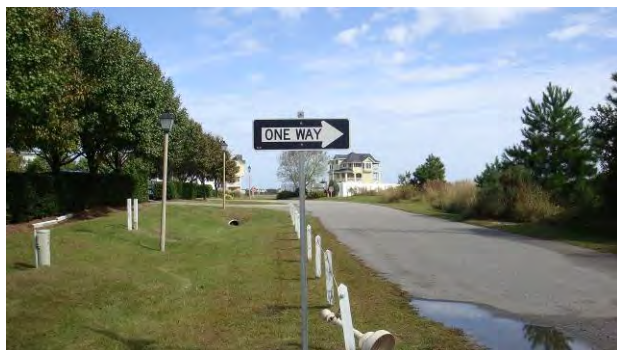
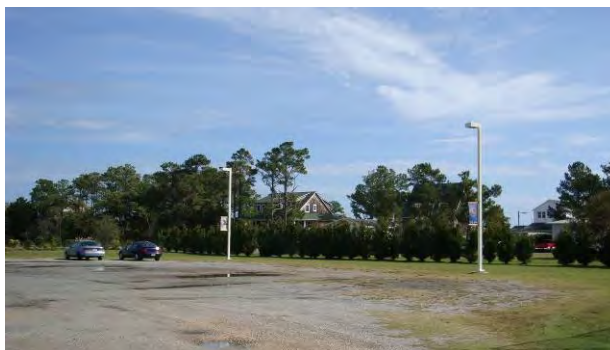
The Roanoke Island Campus also has a combination of natural and structural barriers that identify the perimeter of the campus. North Virginia Dare Road (Hwy 64 Business) forms a barrier on the front or west side of the campus. The entrance to the campus is off of this road and allows for easy access to the campus by vehicle on the west, south, and east sides of the campus. Salty Dawg Lane forms a barrier on the east side of the campus in addition to the water elements.

Vulnerability: There is no real perimeter security around the COA Dare County Campuses, and the properties are used by multiple constituents.

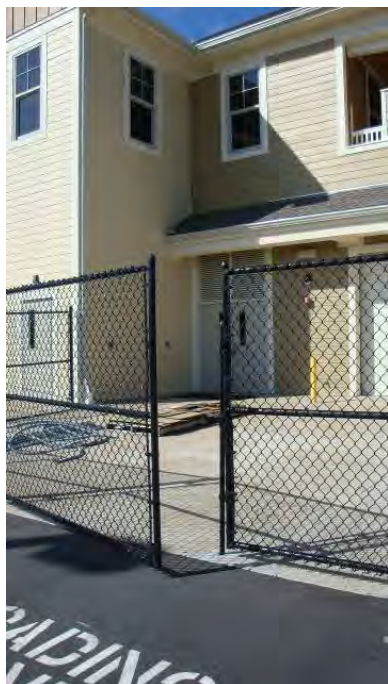
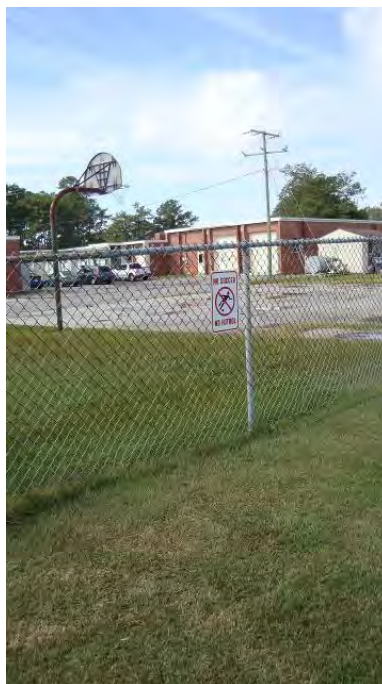
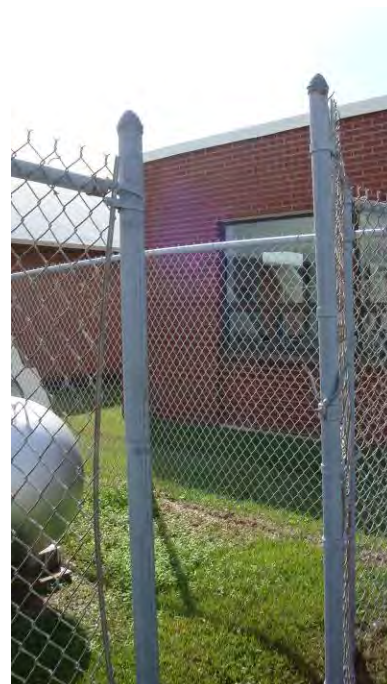
Based on the assessment conducted, fencing although preferred does not appear to be feasible or practical at this time. Fencing is being utilized to protect areas where large assets are stored in an effective manner. The effectiveness of fencing is minimized if it is not kept in good condition and free of vegetation, with gates locked. The care and condition of fence lines are important to the overall effectiveness of presences as a crime deterrent. Gates that are left unlocked invite the curious and persons with nefarious intentions and may produce the perception that an asset is available with anonymity.

Vulnerability: Based on the accessibility and the multiple constituents that may be visiting the campus property at any time, the campus may be seen as an easy target.

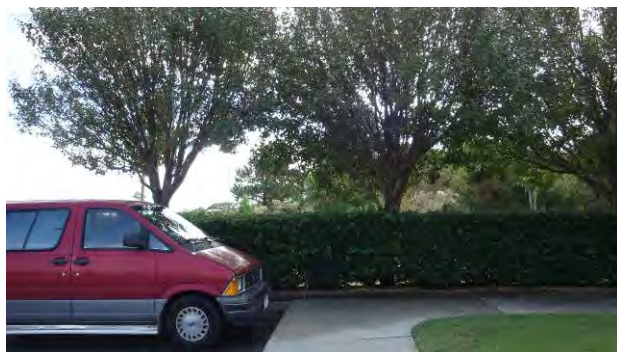
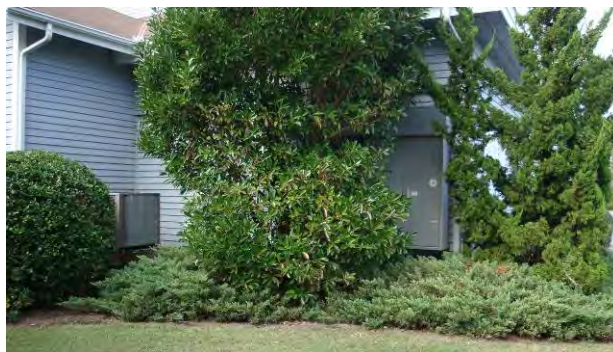
The COA Dare County Campuses are very attractive with a large variety of shrubs and mature trees that can be seen throughout the properties. Security and beauty are not mutually exclusive. The balance is in how the trees and other foliage are maintained. Without careful maintenance, trees will block casual surveillance and provide hiding places for people with nefarious intent to both persons and property. In addition trees and shrubs are blocking the lighting which darkens areas which could lead to accidents and nefarious behaviors.

Vulnerability: Trees with limbs below the 7-foot level and shrubs with foliage above the 2-foot level make the possibility of concealment easier and can prevent both casual surveillance and surveillance by patrolling guards.

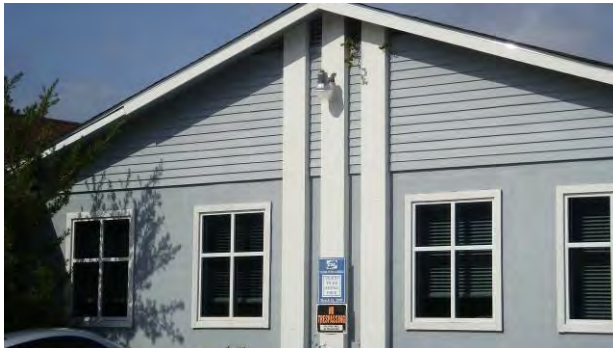
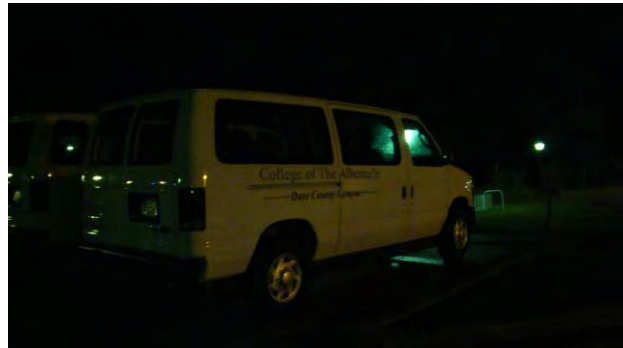
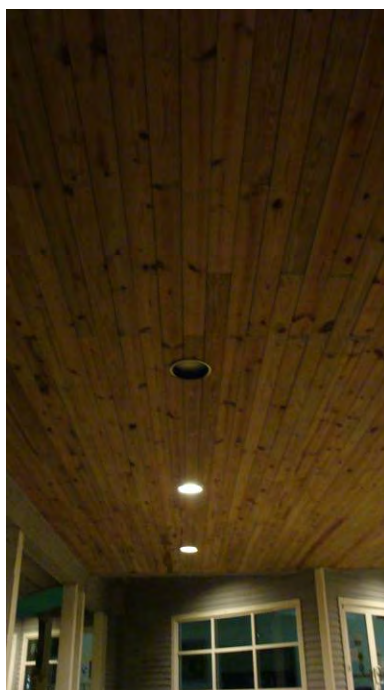
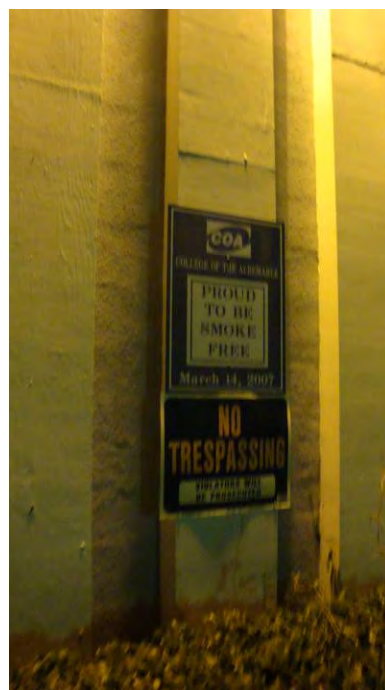
The major portion of the parking areas, entrances/exits, and sidewalks were measured below accepted general industry standards. Some of the lights were burned out or blocked by vegetation but some of the lights just did not produce sufficient light to meet industry standards. Areas just under lights that were not blocked and were working correctly did meet or were close to industry standards. Large trees on the edges of the parking areas were blocking the effectiveness of the lights in parts of the parking lots and created dark areas that were below general industry standards and at times measured 0.0 fc. There were dark areas along the sidewalks. Some of the lights seemed more decorative than functional but may benefit from maintenance that increases the light output. All the existing lights should be maintained for maximum output and bushes and trees trimmed to meet CPTED standards. Once these items are corrected, the lighting should be reevaluated to ensure minimum lighting standards are being met.

The parking lots at the front of the campus were reviewed based on the minimum standards for lighting in parking lots. In areas of the lot where the existing lights were not obstructed by vegetation and the existing light fixtures were working, the lighting met the minimum standards only in close proximity to the lights. In areas of the parking lots where the parking spaces were shaded by trees or lights were not working, the lighting dropped below the minimum standards.
